RESTORING ACTIVE BLANKET BOG IN IRELAND

Project reference: LIFE02NAT/IRL/8490

A REPORT ON THE RESTORATION OF PROJECT SITE No. 18. DERRY, CO.
MAYO

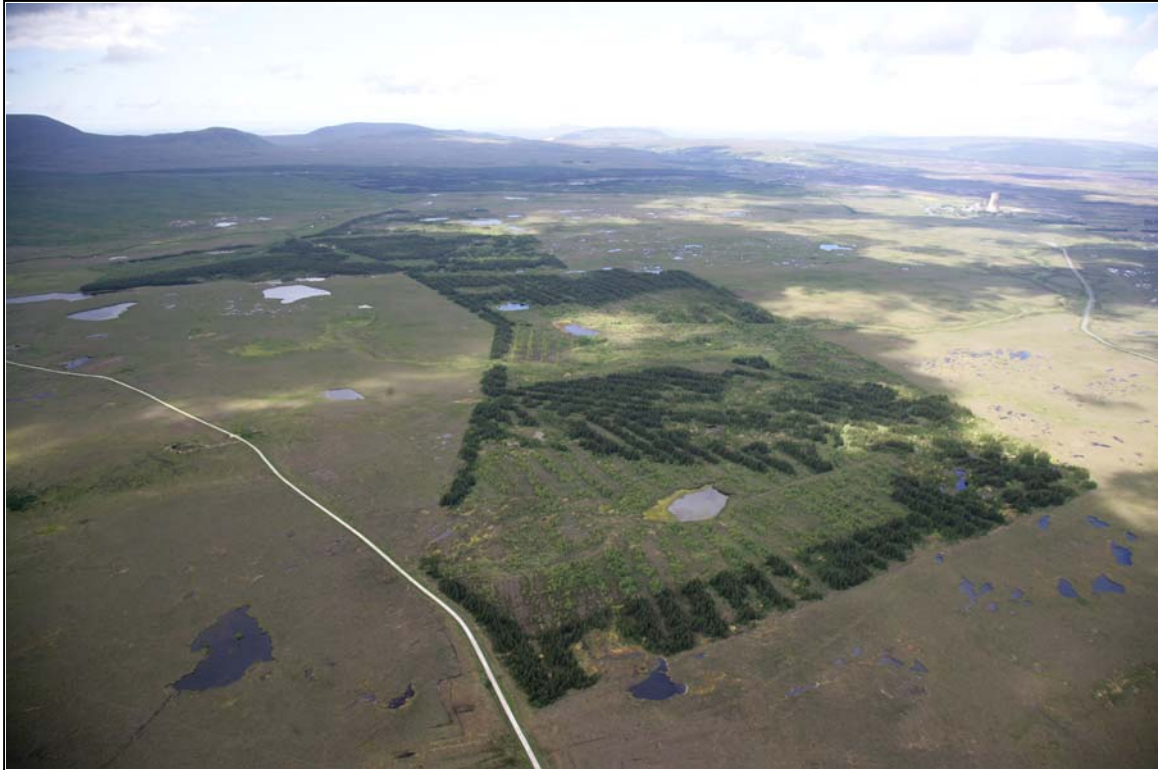
An oblique aerial photograph of the site, looking in a westerly direction, taken in late 2005. Photograph by Neil Warner.

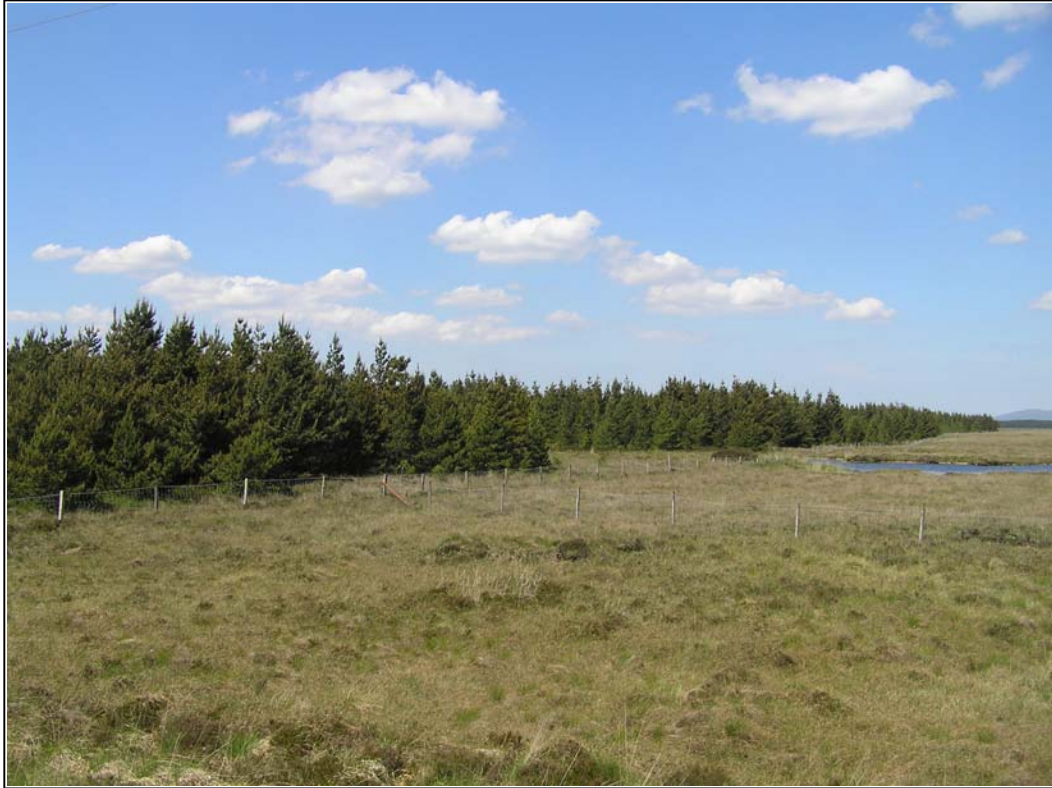
A general view of the eastern edge of the site prior to restoration. Most of the trees planted along the edge of the site were lodgepole pine. Note the high quality intact bog adjoining the plantation. Photograph taken in June 2006.

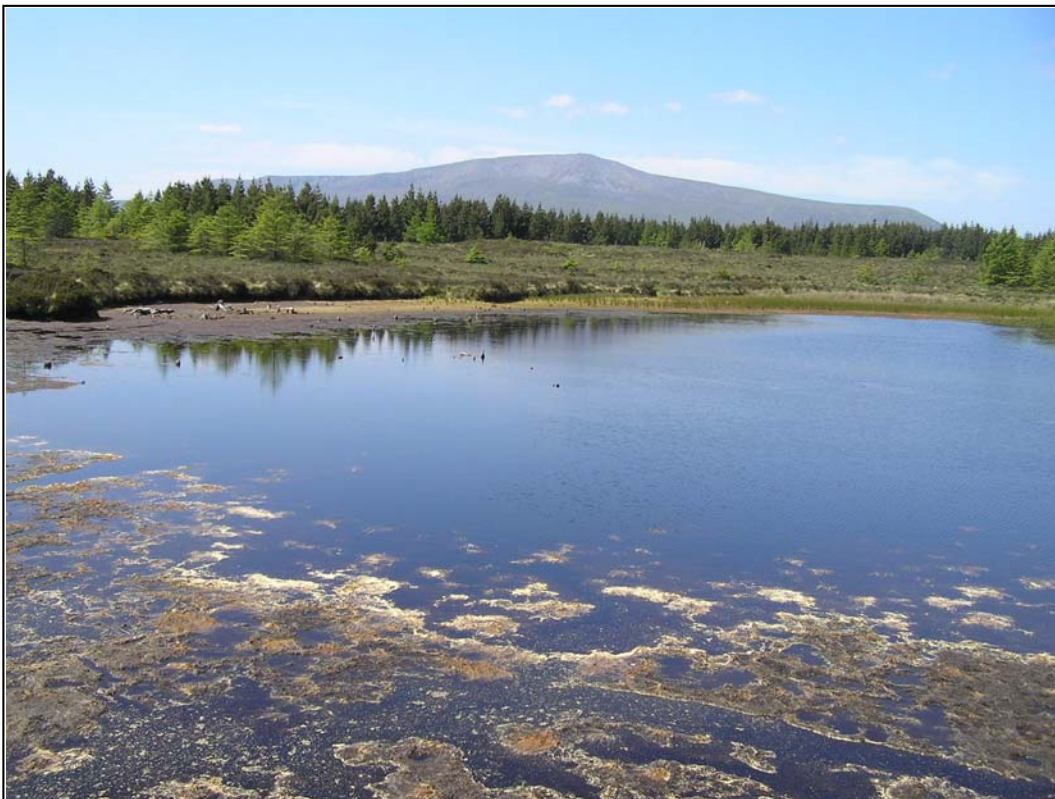
The water levels in this large oligotrophic lake within the site have been seriously lowered by a drain which was inserted in the eastern end of the lake. Photograph taken in June 2006.

A number of small lowland oligotrophic lakes/dystrophic pools occur throughout the site. These are generally colonised by species such as *Menyanthes trifoliata*, *Carex rostrata*, *Eriophorum angustifolium* and *Sphagnum cuspidatum*. At least one of these lakes were drained during site preparation and now have very low water levels, especially in the drier months of the year. In these drained lakes there is generally an expansion of vegetation cover, e.g. *Carex rostrata* swamp, along the margins of the dried-out lake beds.

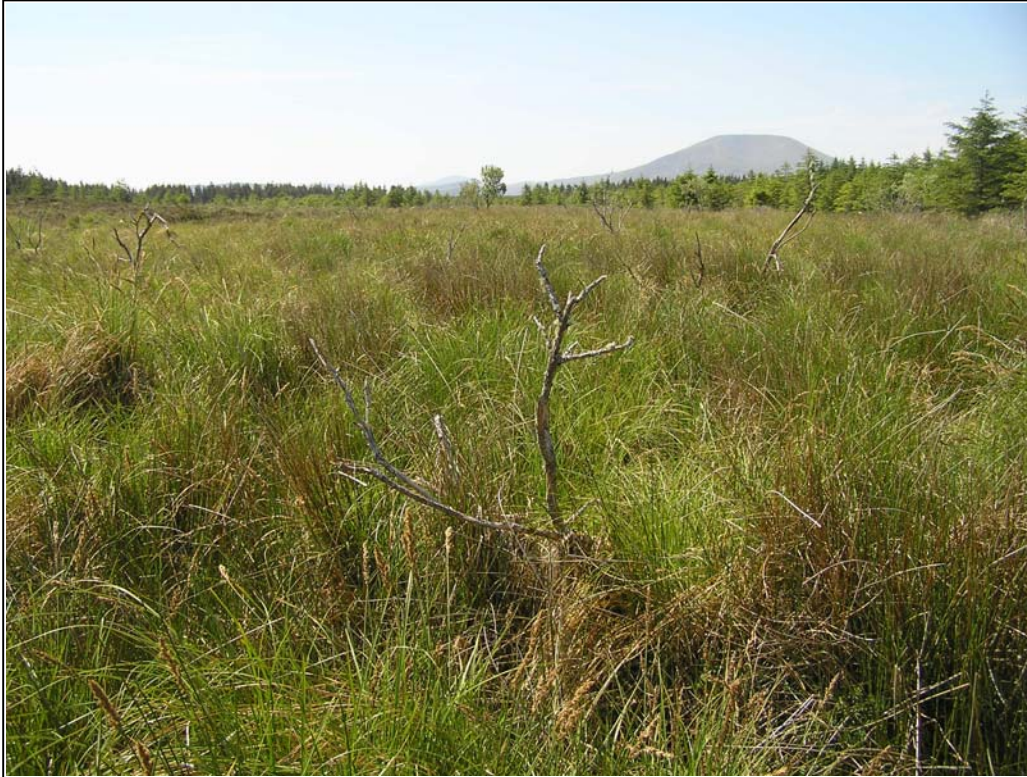
A well developed flush system, dominated by the robust sedge *Carex paniculata*, dominates a wide drainage channel in the eastern half of the site. Plant species such as *Myrica gale* and *Juncus effusus* are also frequent. The bog adjoining the flush was planted with conifers but the flush itself was not planted. Photograph taken in June 2006.

A well developed bog flush occurs in the eastern half of the site. The flush occupies a natural drainage channel which runs a south to north direction, eventually joining up with the Muing/Owenmore river. The dominant plant species of the flush/channel is the large sedge *Carex paniculata*. Other prominent plant species recorded include *Juncus effusus*, *Myrica gale*, *Juncus effusus*, *Carex rostrata*, *Potentilla palustris*, *Sphagnum recurvum* and *Sphagnum cuspidatum*. There are also occasional low shrubs of willow (mostly *Salix aurita*). On the day of survey there was no distinct channel with flowing water observed in the flush however it is likely that diffuse channels are present during very wet periods of the year. Well developed flushed channels in blanket bog such as this are relatively rare in a national context and thus are very important features. Although the adjoining blanket bog was planted with conifers the flush itself was not planted. See Table 1 for a more complete list of plant species growing in the flush.

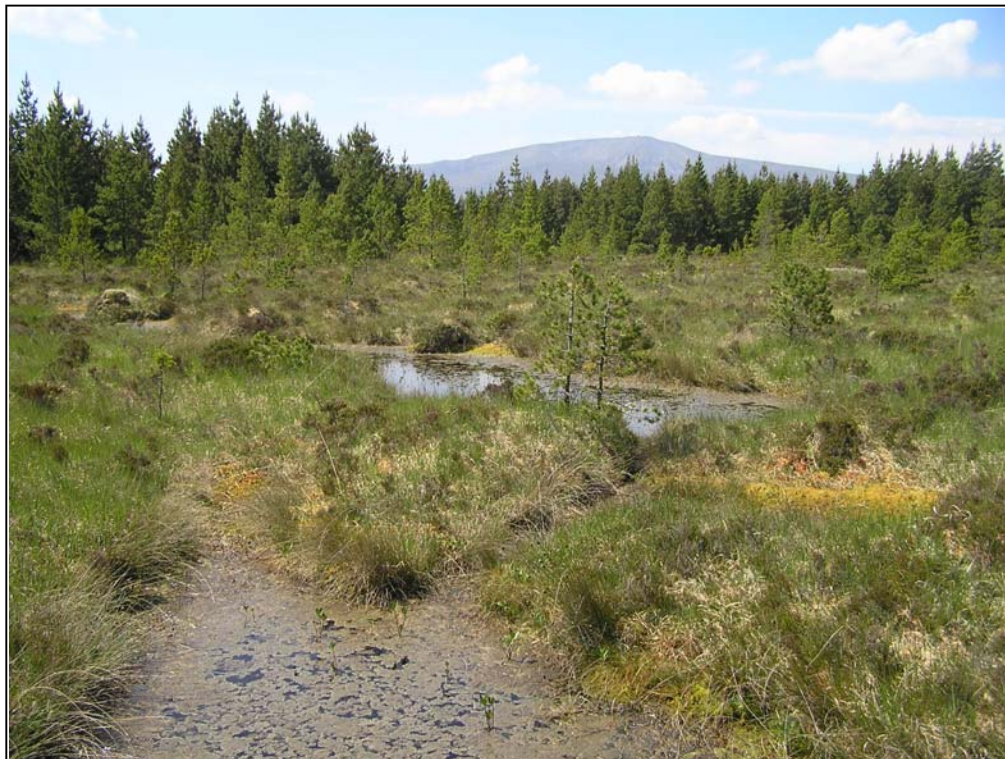
The site contains a number of open bog areas with pool complexes. Most of these are colonized by occasional, self-seeded, lodgepole pine trees which have been felled to waste. Photograph taken in June 2006.

A number of small areas of lowland blanket bog within the site were not planted with conifers due to their very wet nature. A number of small open, pool-studded, areas occur especially in the western half of the site. Such areas are usually surrounded by afforested blanket bog and are subject to invasion by naturally regenerated lodgepole pine. These small areas of open bog still retain a reasonably intact blanket bog flora.

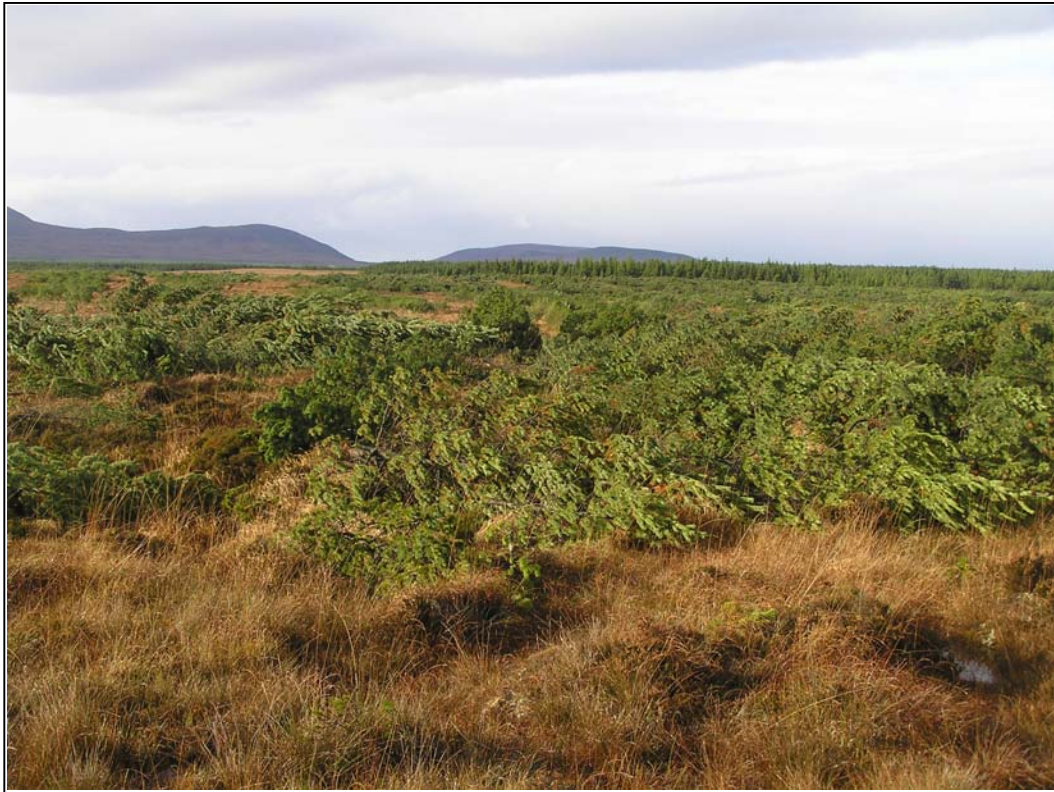
A general view of conifers which were felled to waste. Note the largely intact surrounding bog flora. In areas such as this, where conifer cover was not particularly dense, the trees were not windrowed. Photograph taken in February 2007.

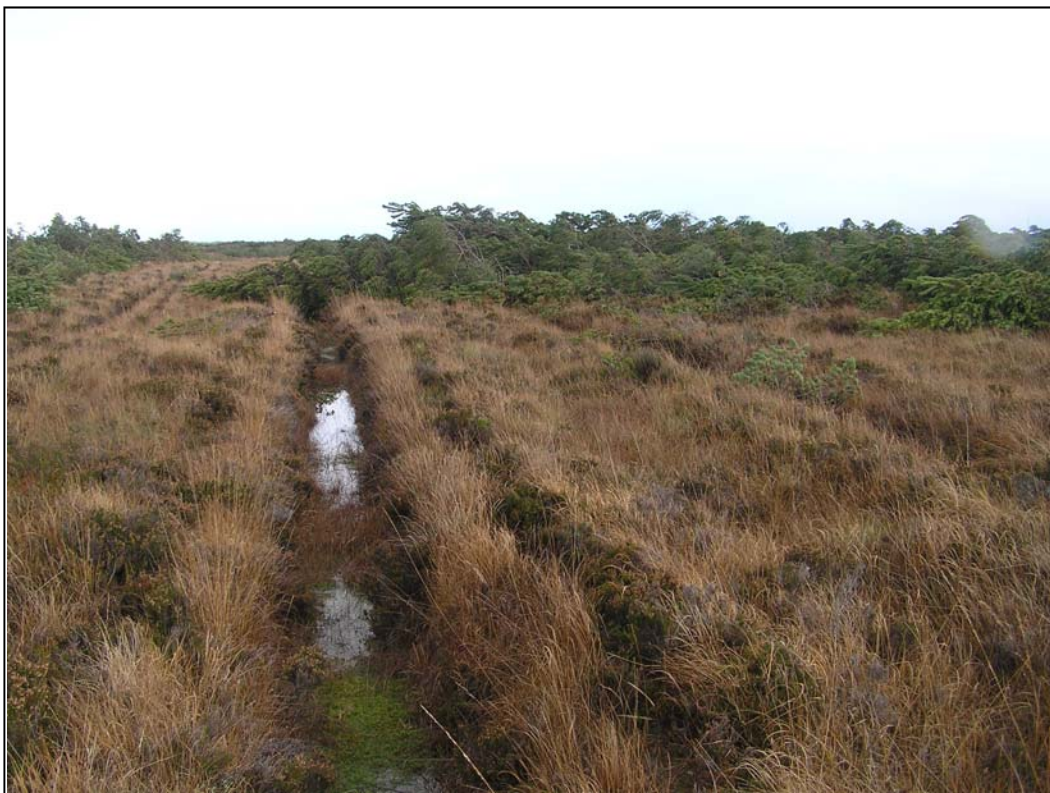
Deep bog drains such as this one were blocked as part of the restoration programme. Photograph taken in February 2007.

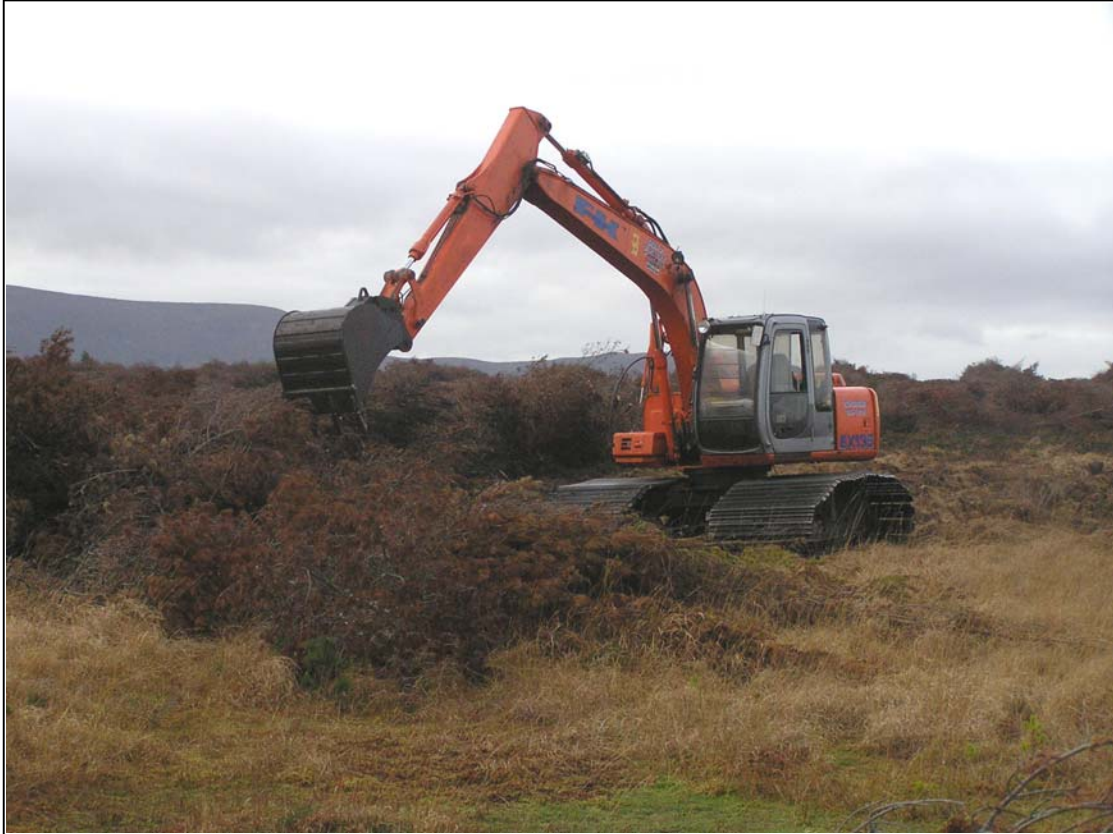
Windrowing of felled trees by machine. Photograph taken in November 2007.

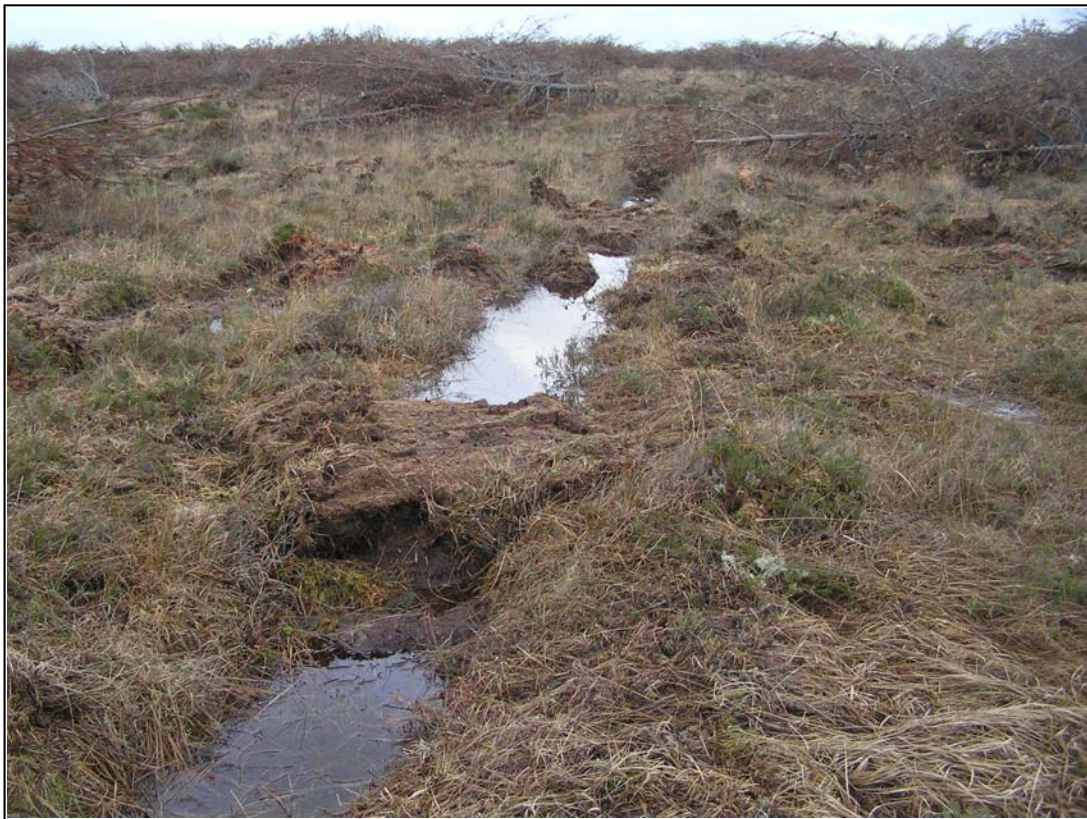
A view of peat dams in drains. These dams were inserted by machine. Photograph taken in November 2007.

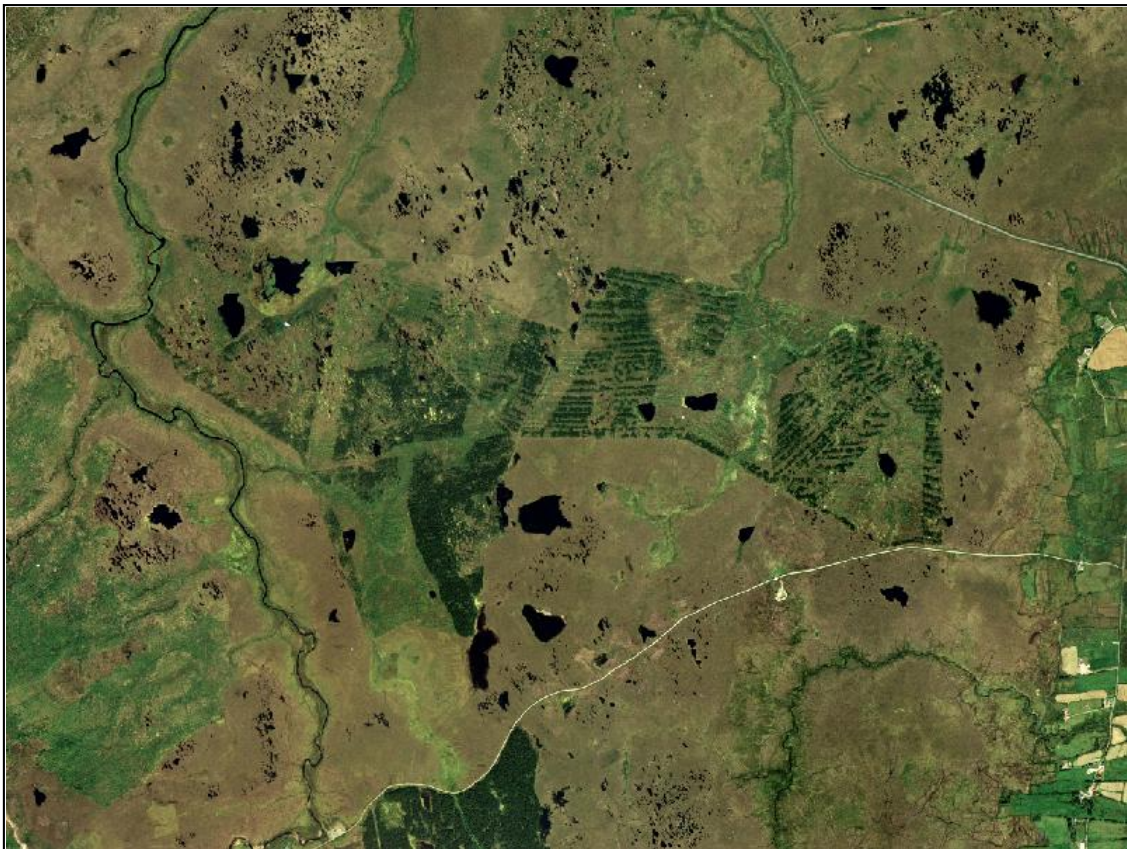
An aerial photograph of the Derry site prior to restoration work taking place. Aerial photograph taken in the year 2000. No post-restoration aerial photograph is available.

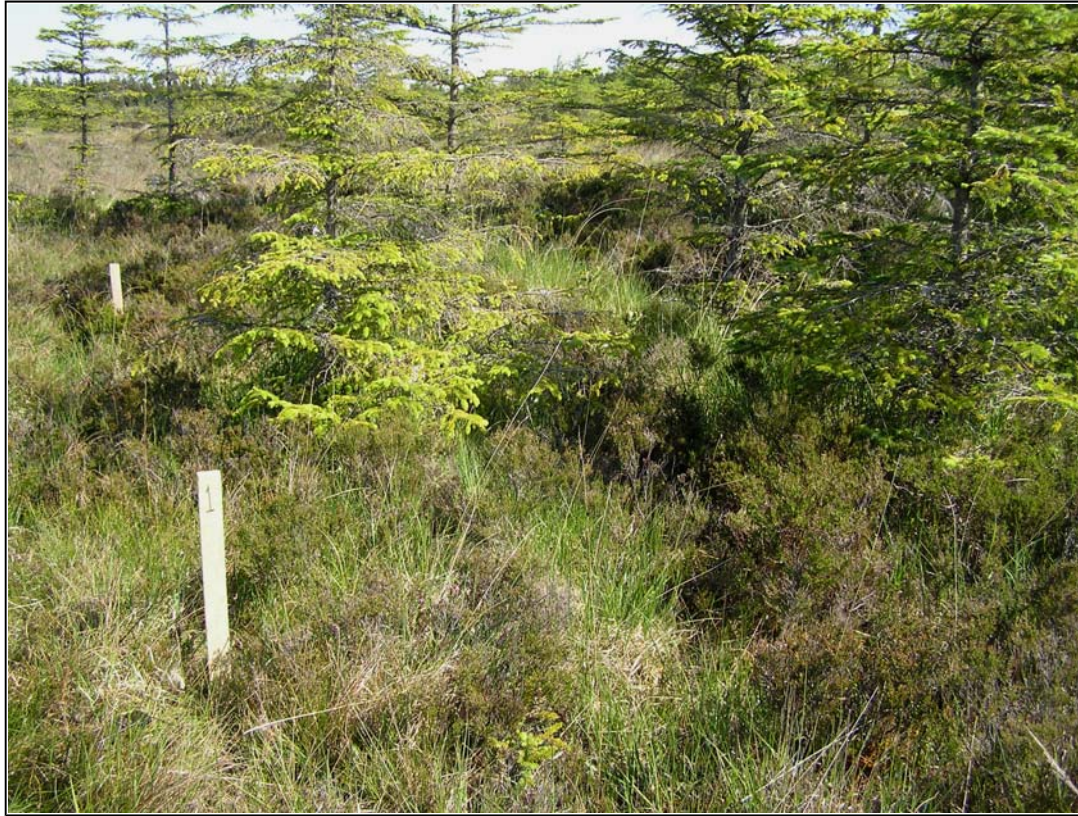
Quadrat 1 – June 2006

Quadrat code	D1	Vegetation cover (%)	100	Date – 8/06/06	
Size (m ²)	36	Bare rock cover (%)	0	No. of plant species in quadrat - 25	
Slope (degrees)	0	Bare water cover (%)	0	Grazed? - No	
Aspect (degrees)	0	Open water cover (%)	0	GPS reading – F 98546 17188	
Height of vegetation (cm)	20-30	Tree cover	25	Substrate – Desiccated peat	
Dwarf shrub cover (%)	40	Herb cover (%)	50		
		Bryophyte cover (%)	75		
<hr/>					
<i>Calluna vulgaris</i>	5	<i>Cladonia portentosa</i>	2	<i>Diplophyllum albicans</i>	1
<i>Molinia caerulea</i>	5	<i>Dicranum scoparium</i>	2	<i>Drosera rotundifolia</i>	1
<i>Sphagnum capillifolium</i>	5	<i>Erica tetralix</i>	2	<i>Eriophorum vaginatum</i>	1
<i>Picea sitchensis</i>	5	<i>Hylocomium splendens</i>	2	<i>Hypnum cupressiforme</i>	1
<i>Sphagnum palustre</i>	4	<i>Pedicularis sylvatica</i>	2	<i>Narthecium ossifragum</i>	1
<i>Sphagnum magellanicum</i>	4	<i>Potentilla erecta</i>	2	<i>Polygala serpyllifolia</i>	1

Comments: Area planted with Sitka spruce in 1985, but trees are were very poor.

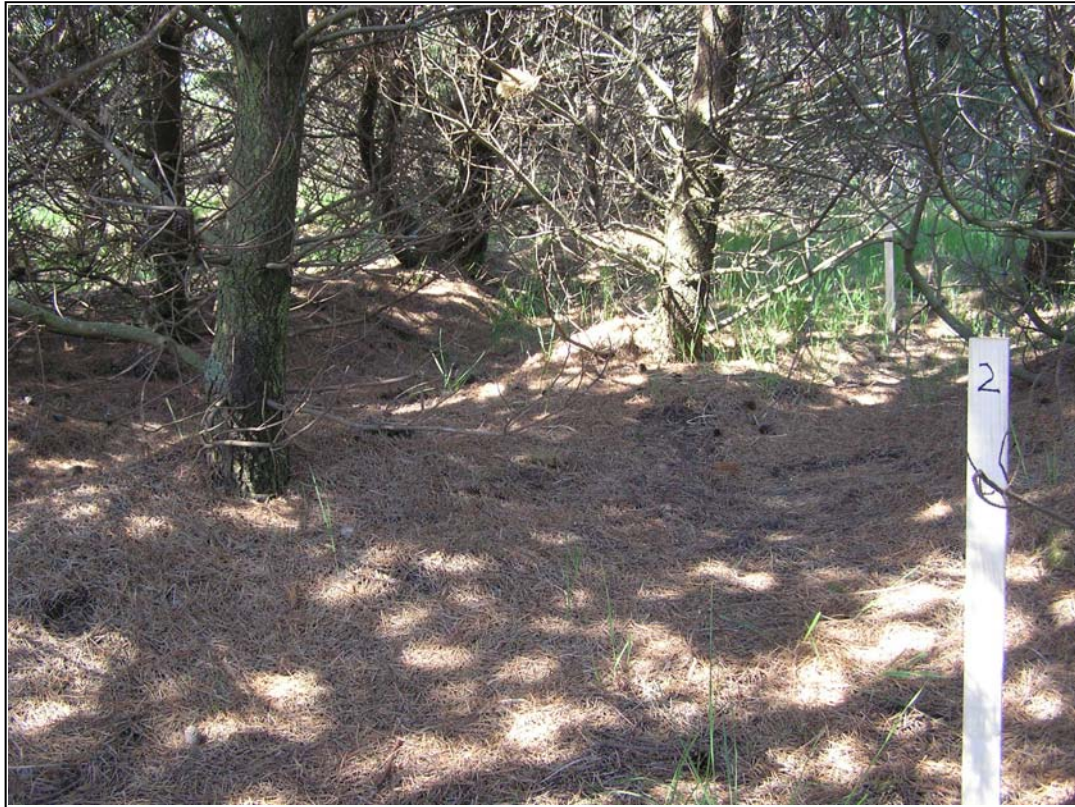
Quadrat 2 – June 2006

Quadrat code	D2	Vegetation cover (%)	100	Date – 8/06/06	
Size (m ²)	36	Bare rock cover (%)	0	No. of plant species in quadrat - 6	
Slope (degrees)	0	Bare soil cover (%)	0	Grazed? - No	
Aspect (degrees)	0	Needle litter cover (%)	0	GPS reading – F 98554 17523	
Height of vegetation (m)	8 - 12	Tree cover	90	Substrate – Desiccated peat	
Dwarf shrub cover (%)	0	Herb cover (%)	5		
		Bryophyte cover (%)	5		
<i>Pinus contorta</i>	7	<i>Hypnum cupressiforme</i>	3	<i>Leucobryum glaucum</i>	1
<i>Molinia caerulea</i>	3	<i>Eurhynchium praelongum</i>	1	<i>Rhytidiadelphus loreus</i>	1
Comments: Area planted with Lodgepole pine in 1985 and the trees grew quite well.

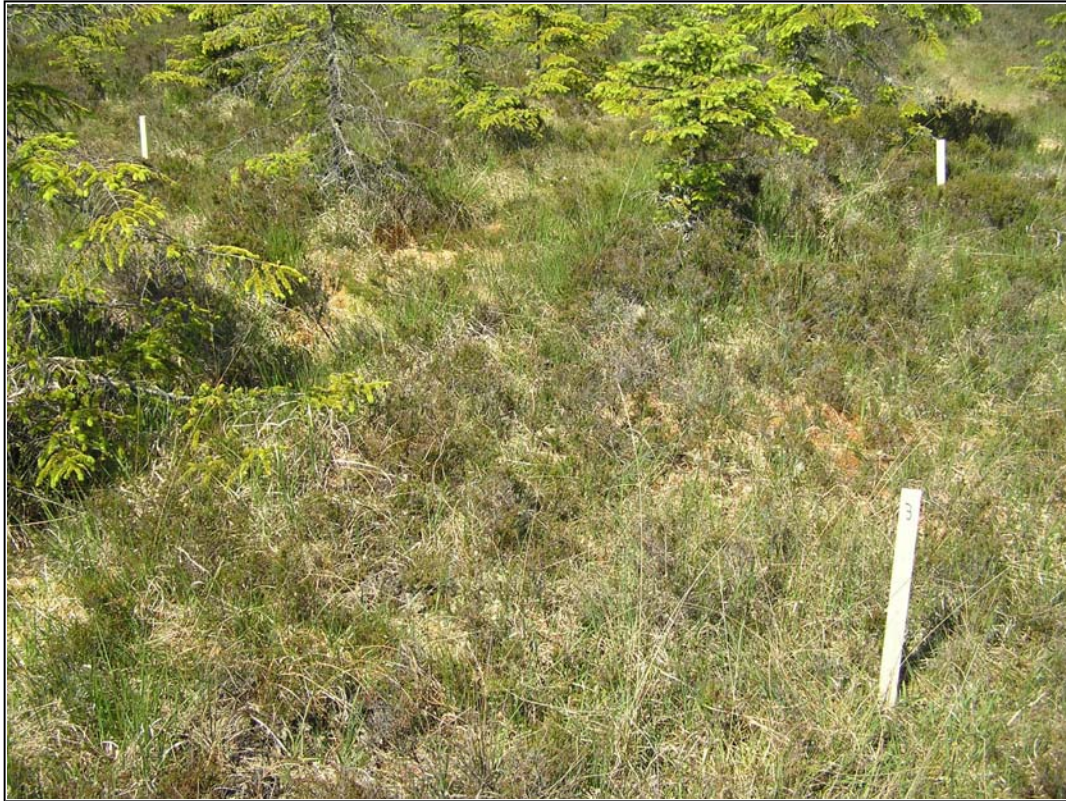
Quadrat 3 – June 2006

Quadrat code	D3	Vegetation cover (%)	100	Date – 8/06/06	
Size (m ²)	36	Bare rock cover (%)	0	No. of plant species in quadrat - 23	
Slope (degrees)	0	Bare soil cover (%)	0	Grazed? - No	
Aspect (degrees)	0	Open water cover (%)	0	GPS reading – F 98008 17658	
Height of vegetation (cm)	20-30	Tree cover	10	Substrate – Desiccated peat	
Dwarf shrub cover (%)	30	Herb cover (%)	40		
		Bryophyte cover (%)	85		
<i>Sphagnum capillifolium</i>	6	<i>Hypnum cupressiforme</i>	3	<i>Drosera rotundifolia</i>	1
<i>Molinia caerulea</i>	5	<i>Aulacomium palustris</i>	2	<i>Pleurozium schreberi</i>	1
<i>Calluna vulgaris</i>	5	<i>Eriophorum vaginatum</i>	2	<i>Polygala serpyllifolia</i>	1
<i>Cladonia portentosa</i>	5	<i>Hylocomium splendens</i>	2	<i>Polytrichum commune</i>	1
<i>Picea sitchensis</i>	4	<i>Narthecium ossifragum</i>	2	<i>Potentilla erecta</i>	1
<i>Sphagnum papillosum</i>	4	<i>Schoenus nigricans</i>	2	<i>Racomitrium lanuginosum</i>	1

<i>Erica tetralix</i>	3	<i>Sphagnum cuspidatum</i>	2	<i>Rhytidiadelphus loreus</i>	1
<i>Eriophorum angustifolium</i>	3	<i>Sphagnum palustre</i>	2		
<p>Comments: Area planted with Sitka spruce in 1985, but trees were very poor.</p>

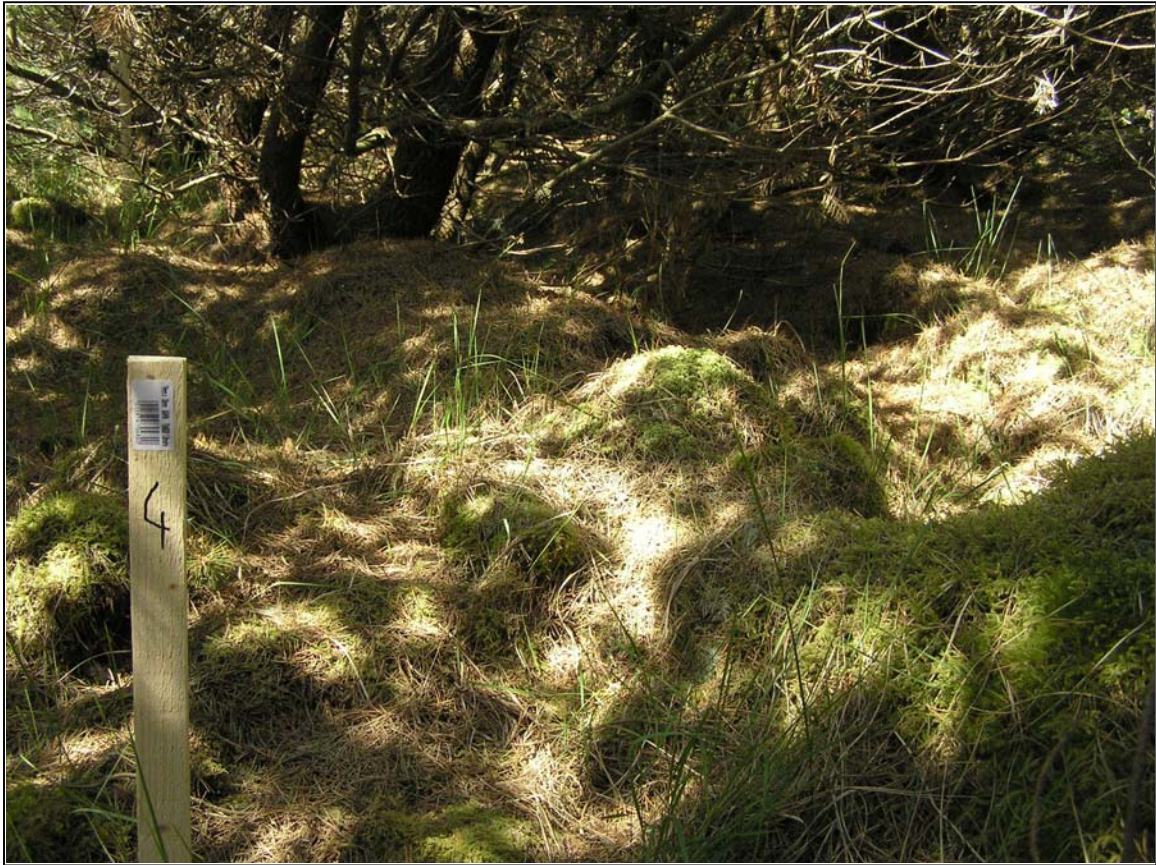
Quadrat 4 – June 2006

Quadrat code	D4	Vegetation cover (%)	100	Date – 8/06/06	
Size (m ²)	36	Bare rock cover (%)	0	No. of plant species in quadrat - 9	
Slope (degrees)	0-5	Needle litter cover (%)	80	Grazed? - No	
Aspect	East	Open water cover (%)	0	GPS reading – F 97657 17509	
Height of vegetation (m)	10-20	Tree cover	90	Substrate – Desiccated peat	
Dwarf shrub cover (%)	0	Herb cover (%)	5		
		Bryophyte cover (%)	40		
<i>Pinus contorta</i>	7	<i>Cladonia portentosa</i>	2	<i>Rhytidiadelphus loreus</i>	2
<i>Hypnum cupressiforme</i>	5	<i>Dicranum scoparium</i>	2	<i>Dryopteris dilatata</i>	1
<i>Sphagnum capillifolium</i>	3	<i>Molinia caerulea</i>	2	<i>Thuidium tamariscinum</i>	1

Comments: Area planted with Lodgepole pine in 1985 and the trees grew quite well.

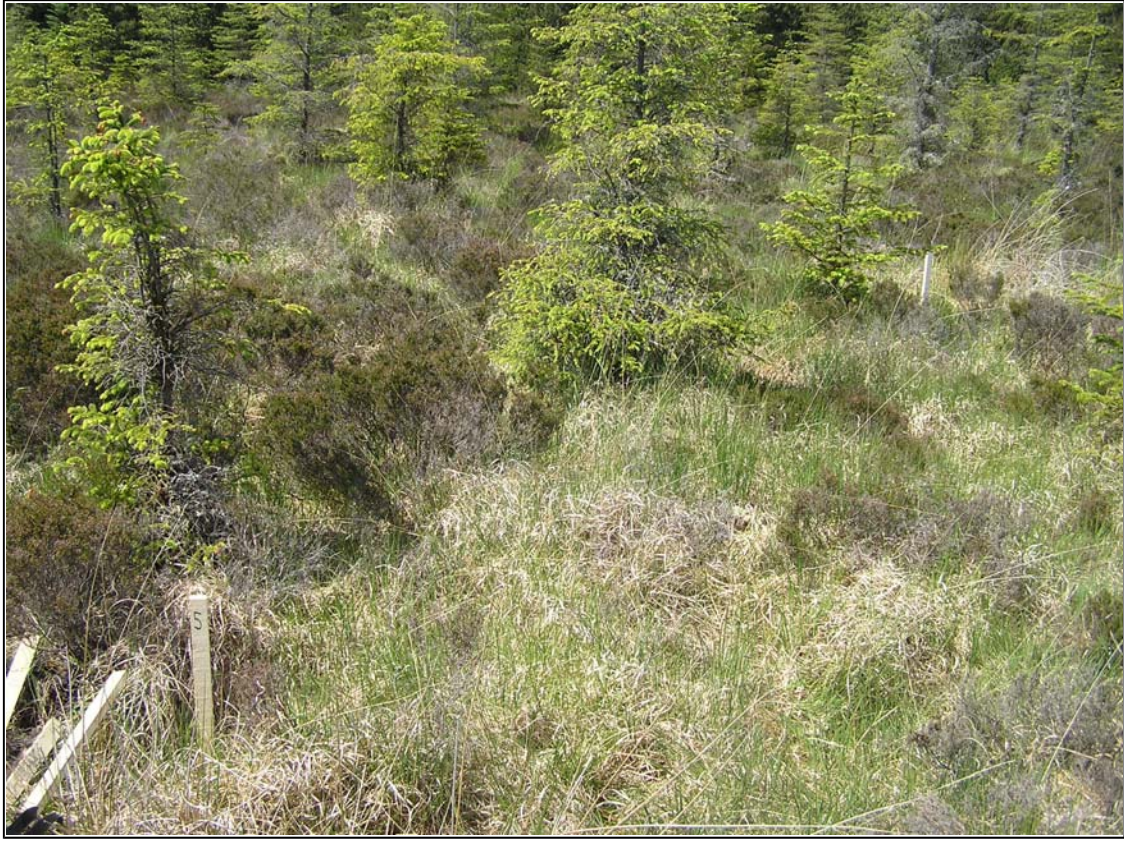
Quadrat 5 – June 2006

Quadrat code	D5	Vegetation cover (%)	100	Date – 8/06/06	
Size (m ²)	36	Bare rock cover (%)	0	No. of plant species in quadrat - 21	
Slope (degrees)	0	Bare soil cover (%)	0	Grazed? - No	
Aspect (degrees)	0	Open water cover (%)	0	GPS reading – F 97150 17520	
Height of vegetation (m)	1.5 – 2.5	Tree cover	10	Substrate – Desiccated peat	
Dwarf shrub cover (%)	40	Herb cover (%)	50		
		Bryophyte cover (%)	70		
<i>Molinia caerulea</i>	5	<i>Sphagnum recurvum</i>	4	<i>Dicranum scoparium</i>	1
<i>Calluna vulgaris</i>	5	<i>Hylocomium splendens</i>	3	<i>Drosera rotundifolia</i>	1
<i>Sphagnum capillifolium</i>	4	<i>Hypnum cupressiforme</i>	3	<i>Juncus effusus</i>	1
<i>Cladonia portentosa</i>	4	<i>Erica cinerea</i>	2	Liverwort spp.	1
<i>Erica tetralix</i>	4	<i>Eriophorum angustifolium</i>	2	<i>Narthecium ossifragum</i>	1

<i>Pleurozium schreberi</i>	4	<i>Polytrichum commune</i>	2	<i>Polygala serpyllifolia</i>	1
<i>Sphagnum papillosum</i>	4	<i>Trichophorum cespitosum</i>	2	<i>Potentilla erecta</i>	1
Comments: Area planted with Sitka spruce in 1985, but trees were very poor.

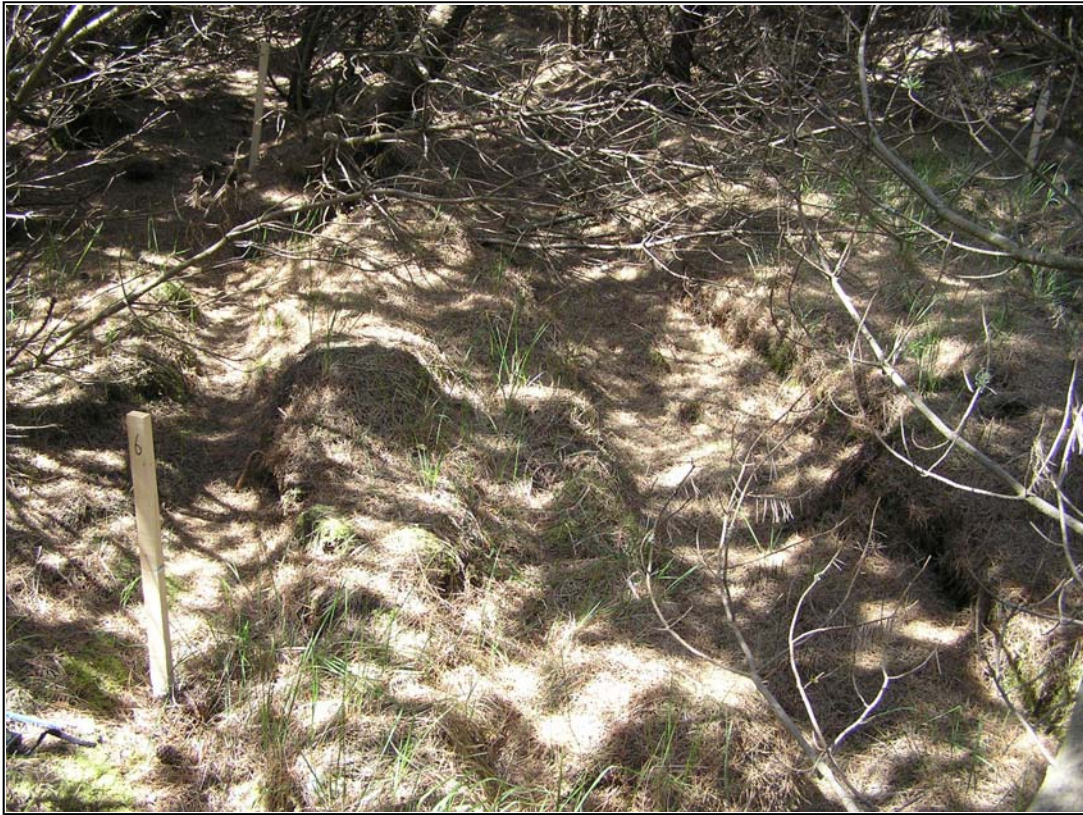
Quadrat 6 – June 2006

Quadrat code	D6	Vegetation cover (%)	100	Date – 8/06/06	
Size (m ²)	36	Bare rock cover (%)	0	No. of plant species in quadrat - 7	
Slope (degrees)	0	Bare soil cover (%)	0	Grazed? - No	
Aspect (degrees)	0	Needle litter cover (%)	80	GPS reading – F 97099 17572	
Height of vegetation (m)	9-12	Tree cover	90	Substrate – Dessiccated peat	
Dwarf shrub cover (%)	0	Herb cover (%)	10		
		Bryophyte cover (%)	25		
<i>Pinus contorta</i>	7	<i>Sphagnum capillifolium</i>	3	<i>Dryopteris dilatata</i>	1
<i>Hypnum cupressiforme</i>	4	<i>Polytrichum commune</i>	1	<i>Dicranum scoparium</i>	1
<i>Molinia caerulea</i>	4				
<p>Comments: Area planted with Lodgepole pine in 1985 and the trees grew quite well.</p>
